A Review On-Study of Use of Bonded Fibre Composite Materials for Repairs of Floating Offshore Units

Y.D.Belekar, M.B.Kumthekar, Amarsinh B. Landage

Department of Civil Engineering, Government College of Engineering, Karad, Maharashtra, India

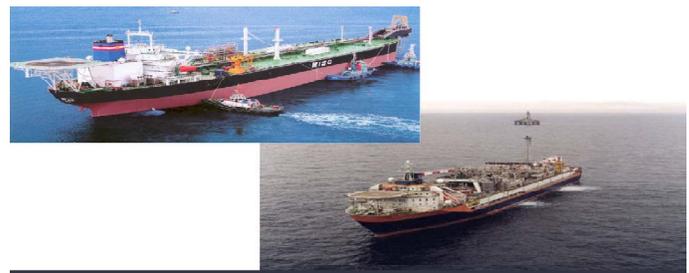
Fig. 1. Floating offshore units are widely used in today's offshore oil and gas mining.
